AFRL-PR-WP-TR-2002-2061

**JP-8+100 ENGINE DEMONSTRATION
Industry Version**

MARCH 2002

Final Report for 23 June 1995 – 30 July 2000

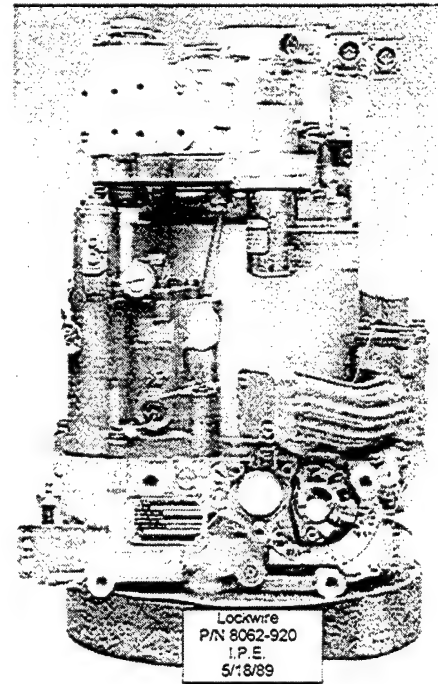
Figure 1 ESN 538103/5, 5A, 5B, and 5C Clean Layout Results: Main Engine Control

Observations: The MEC was found to be in generally excellent condition. It was very clean internally. Seals, O-rings, wear surfaces, and bearings exhibited no unusual wear or distress. No safety issues or early removal for cause were identified.

Disposition/Recommendation: Recommend that the MEC can be run for additional blocks of testing.

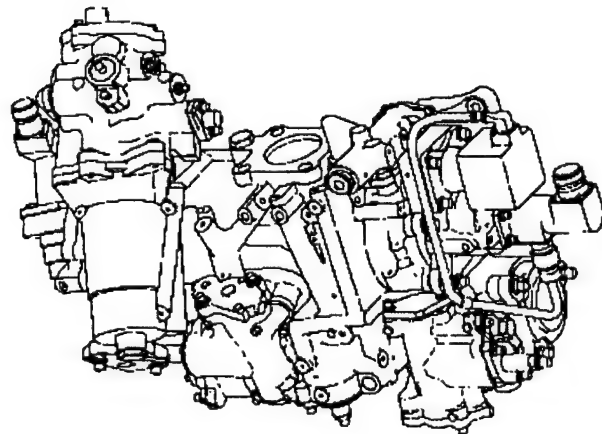
Figure 2. ESN 538103/5, 5A, 5B, and 5C Clean Layout Results: Augmentor Fuel Control

Observations: Posttest component within acceptance test procedure (ATP) limits. Handling damage to A/B on/off solenoid connector precluded testing of that function. Disassembly of control revealed "very clean" piece parts.

Disposition/Recommendation: Reassemble with new solenoid and use for acceptance test. No restrictions on additional engine tests.

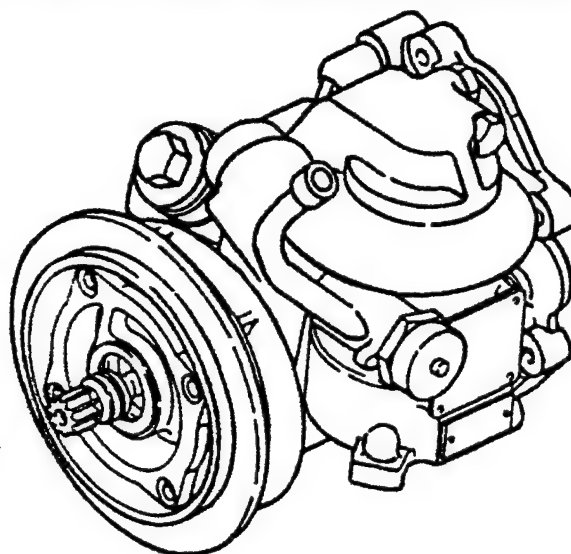
Figure 3. ESN 538103/5, 5A, 5B, and 5C Clean Layout Results: Main Fuel Pump

- No deterioration in performance.
- All elastomers in excellent condition.
- All parts in excellent condition except:
 1. Wear on filter bypass poppet seat not associated with JP-8+100.
 2. Impending bypass indicator would reset — not exposed to fuel.

- Reassemble pump. Return to Engineering Stores or engine operation.
- JP-8+100 fuel acceptance for Main Fuel Pump

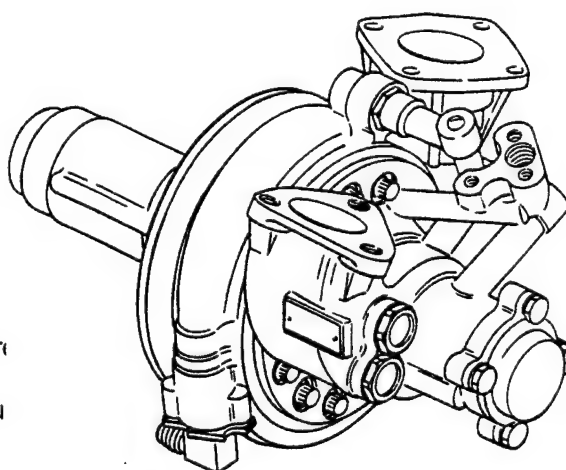
Figure 4. ESN 538103/5, 5A, 5B, and 5C Clean Layout Results: Augmentor Fuel Pump

- No deterioration in performance.
- All elastomers in excellent condition.
- All parts in excellent condition except inlet valve piston and stem damaged during disassembly.

- Reassemble pump and return to Engineering Store or engine operation.
- JP-8+100 fuel is acceptable for augmentor fuel pu

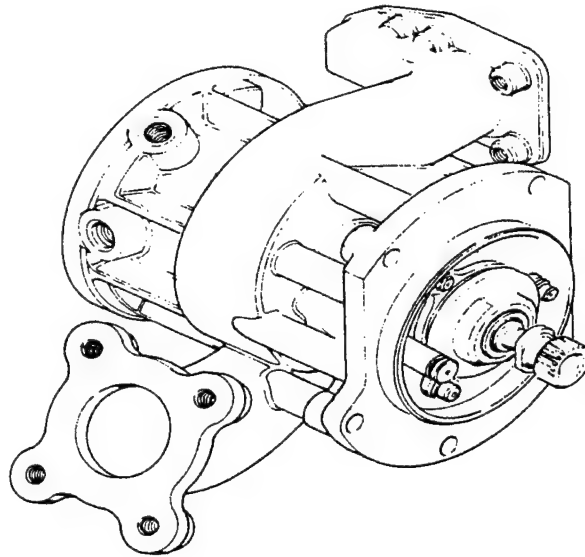
Figure 5 ESN 538103/5, 5A, 5B, and 5C Clean Layout Results: Fuel Boost Pump

Teardown is complete. All internal components are in excellent condition. There are indications of cavitation on "C" element blade tips, liner, and adjacent bearings.

- Wear measurements complete. All parts within T.O. limits.
- No degradation of elastomeric seals due to exposure to JP-8+100 fuel.
- One carbon seal broken during disassembly. No abnormal wear patterns observed.

- Rebuild pump and return to Engineering Stores.
- Fuel boost pump OK to use with JP-8+100 fuel.

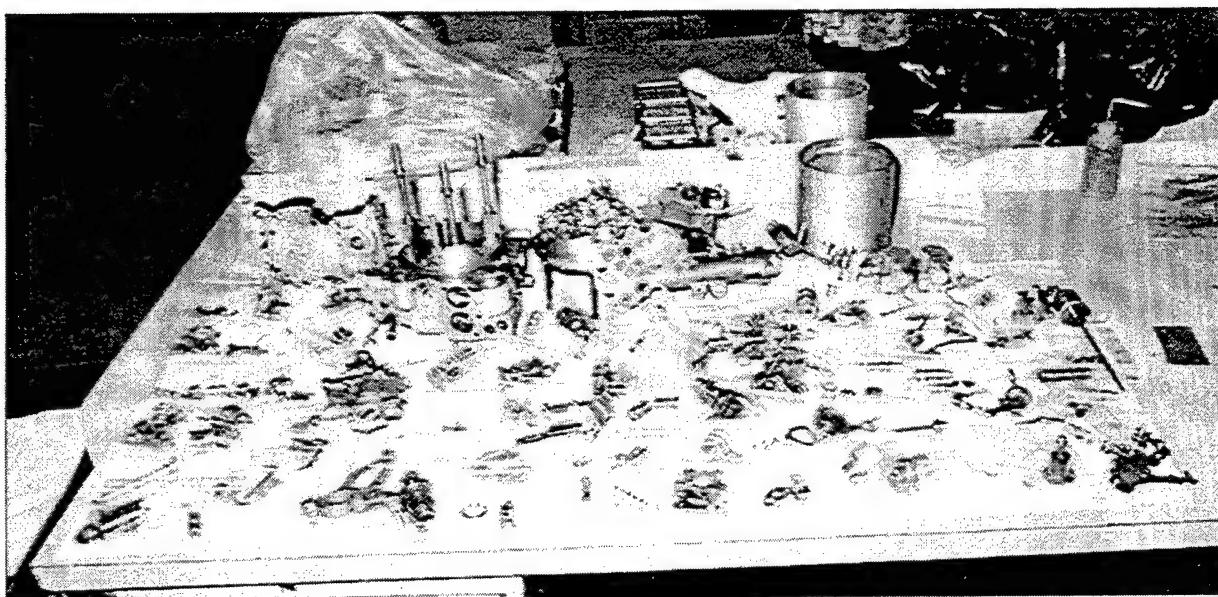
Figure 6 Main Fuel Control, Dirty Layout ESN 488109/6 - *Parts look very clean.*

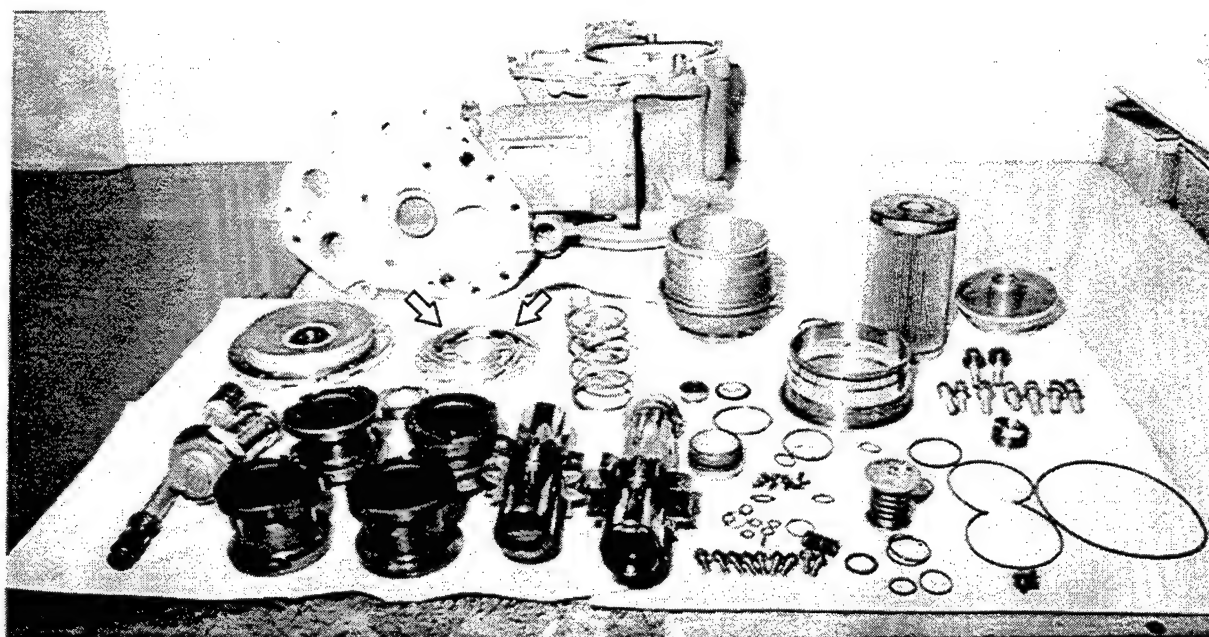
Figure 7 Main Fuel Pump, Dirty Layout ESN488109/6 - *Note chunks of rubber in impeller*

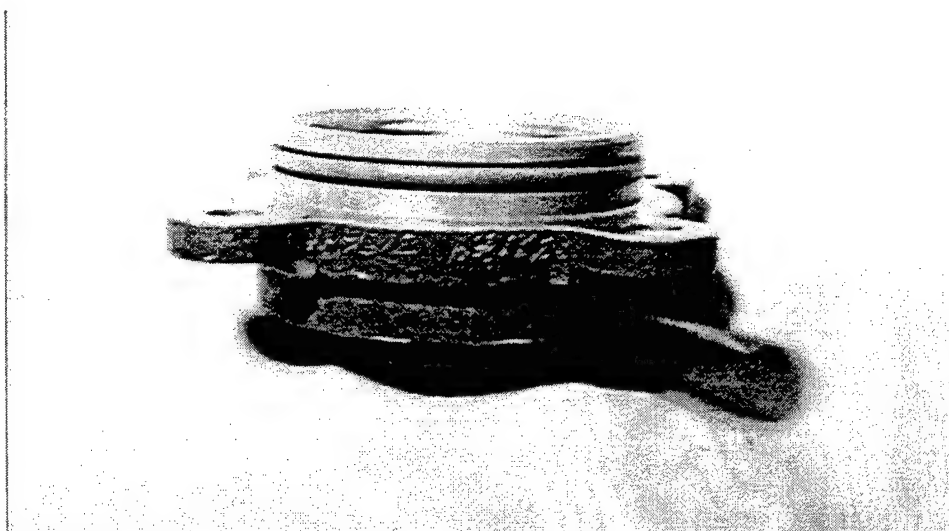
Figure 16 Typical O-Ring from Augmentor Fuel Pump *Little wear evident.*
